DEPARTMENT OF TRANSPORTATION

Quality Assurance and Source Inspection

WELDING INSPECTION REPORT

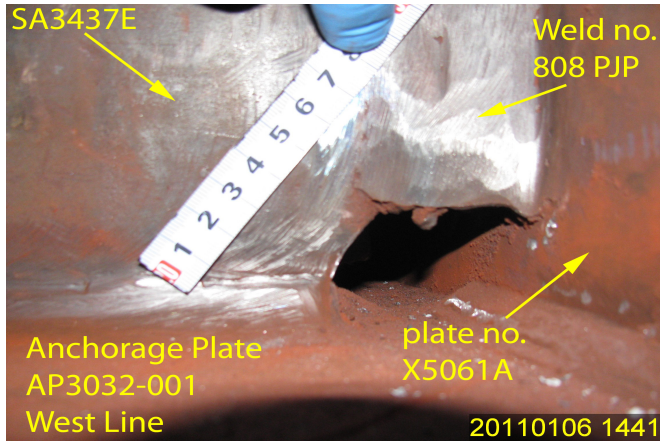
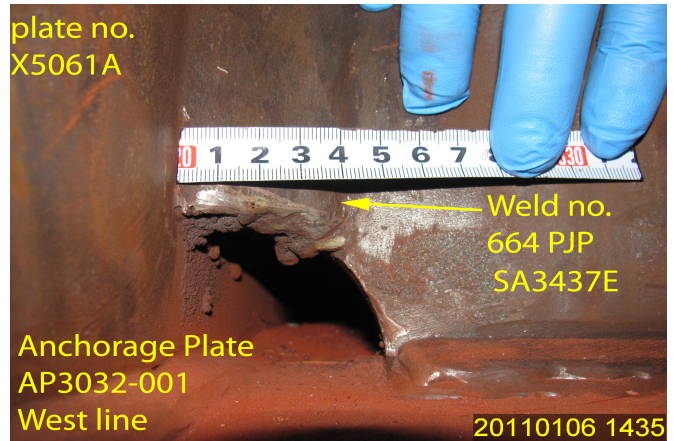
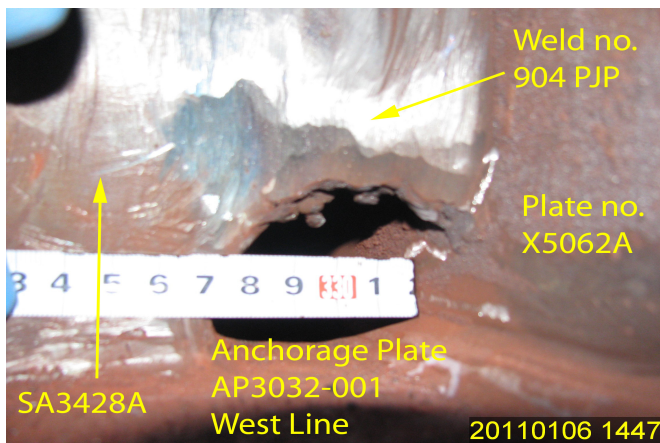
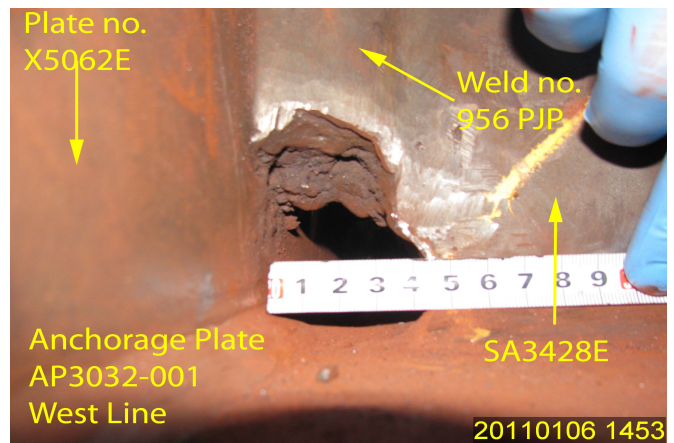
Cope holes at the bottom of the identified Partial Penetration Joint welds in the photos below were found to have unacceptable profiles. This is a representative sample of typical conditions at most cope holes on this West Line Anchorage Plate.
